**Flood Control Project Maintenance
Levee Inspections**

Maintenance Issue Types Only, Levee Inspection Report By Mile - Spring 2016

Reclamation District No. 0785 Driver

Waterway	Bank	Unit Miles	Inspection Start/End	Inspector
Unit No. 01 Sacramento River	Right	2.26	05/12/2016 05/12/2016	Jai Lor

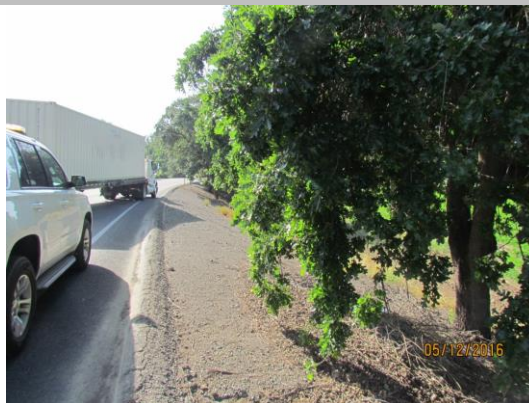
Photo 1 of 1 : SP_2016_RD0785_185_19_20160516_00030.jpg

LM Start	0.10	Rating **	M	Issue No.	19
LM End	0.10	Issue Type +	Ma	Location *	LS
Category	Earthen Levee			GPS Latitude/Longitude	
				Start	End
Item	Trim / Thin Trees			38.660320 °	38.660320 °
				-121.611973 °	-121.611973 °
DWR ID	DWR_RD0785_01_s_2016_19				
Comment Code					
T1 : Trim trees to at least five feet above ground level.					
Inspector Comment

View of the tree on the landward side of the levee looking downstream. Spring 2016.

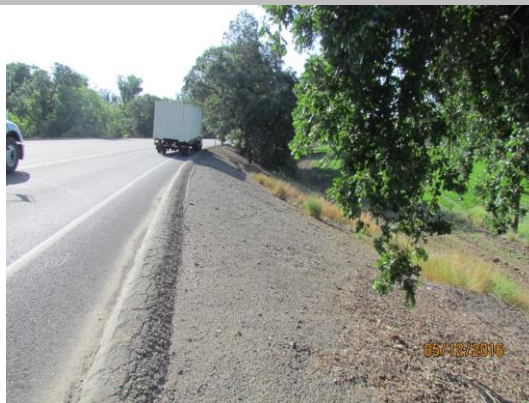
Photo 1 of 1 : SP_2016_RD0785_185_20_20160516_00031.jpg

LM Start	0.10	Rating **	A	Issue No.	20
LM End	1.39	Issue Type +	Ma	Location *	LS
Category	Earthen Levee			GPS Latitude/Longitude	
				Start	End
Item	Vegetation			38.660319 °	38.645627 °
				-121.611970 °	-121.597981 °
DWR ID	DWR_RD0785_01_s_2016_20				
Comment Code					
V1 : Control annual grass and weeds on the levee slopes and easements.					
Inspector Comment					
Vegetation on slope has been maintained.

View of the vegetation on the landward side of the levee looking downstream. Spring 2016.

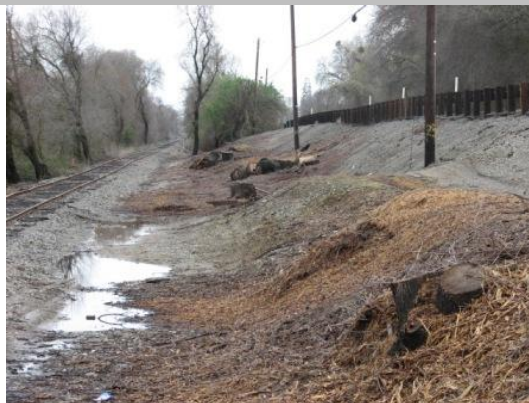
Photo 1 of 1 : SP_2016_RD0785_185_4_20160304_00001.jpg

LM Start	0.12	Rating **	N	Issue No.	4
LM End	1.34	Issue Type +	Ma	Location *	LS
Category	Earthen Levee			GPS Latitude/Longitude	
				Start	End
Item	Trim / Thin Trees			38.660160 °	38.646214 °
				-121.611619 °	-121.598596 °
DWR ID	DWR_RD0785_01_s_2012_4				
Comment Code					
T5 : Tree stumps.					
Inspector Comment

The trees were cut by PG&E'S tree contractor. The district will take care of the stumps in the future.

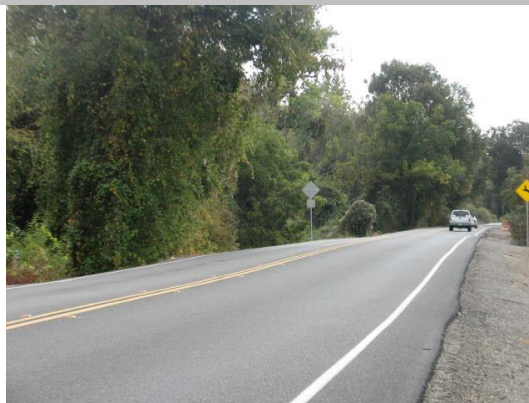
Photo 1 of 2 : SP_2016_RD0785_185_16_20160304_00007.jpg

LM Start	0.21	Rating **	M	Issue No.	16	
LM End	1.35	Issue Type +	Ma	Location *	WS	
Category	Earthen Levee			GPS Latitude/Longitude		
				Start		End
Item	Vegetation			38.659340 °		38.646093 °
				-121.610405 °		-121.598518 °
DWR ID	DWR_RD0785_01_f_2013_16					
Comment Code						
V2 : Remove the wild growth other than native grasses from the levee slopes.						
Inspector Comment

Brush and other vegetation partially blocks visibility or access to the levee slope. Fall 2013

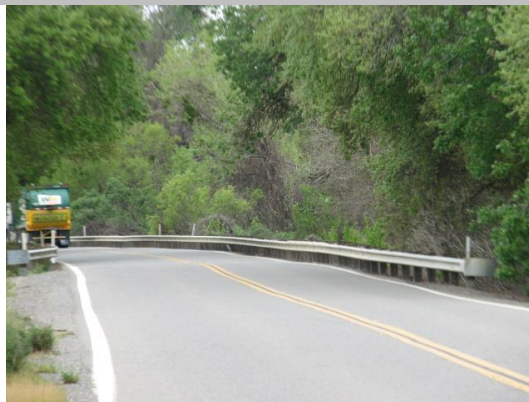
Photo 2 of 2 : SP_2016_RD0785_185_16_20160304_00008.jpg

Brush and other vegetation partially blocks visibility. Spring 2014

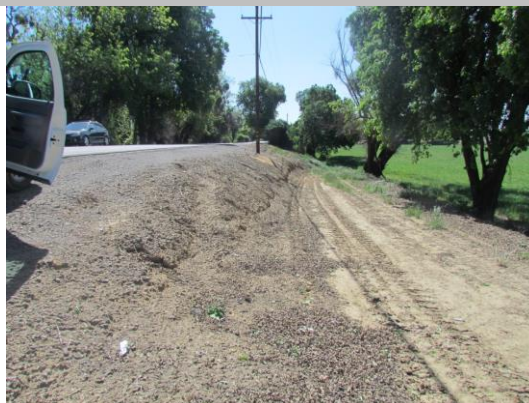
Photo 1 of 1 : SP_2016_RD0785_185_349_20160304_00016.jpg

LM Start	0.34	Rating **	M	Issue No.	349
LM End	0.34	Issue Type +	Ma	Location *	LS
Category	Earthen Levee			GPS Latitude/Longitude	
				Start	End
Item	Slope Stability			38.657798 °	38.657798 °
				-121.608898 °	-121.608898 °
DWR ID	DWR_RD0785_01_s_2015_349				
Comment Code					
S1 : Repair slope instability.					
Inspector Comment

View of the slope stability on the landward side of the levee looking downstream. Spring 2015.

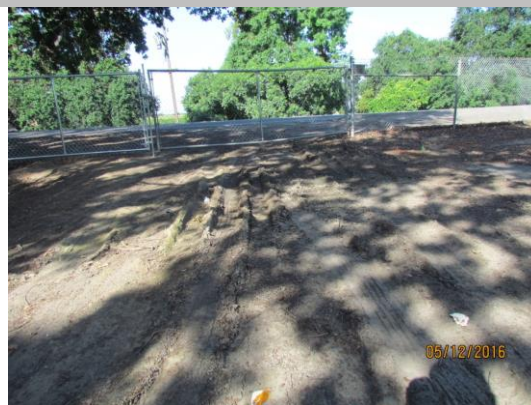
Photo 1 of 1 : SP_2016_RD0785_185_21_20160516_00035.jpg

LM Start	0.58	Rating **	M	Issue No.	21
LM End	0.58	Issue Type +	Ma	Location *	CR
Category	Earthen Levee			GPS Latitude/Longitude	
				Start	End
Item	Crown Surface / Depressions / Rutting			38.655077 °	38.655077 °
				-121.606237 °	-121.606237 °
DWR ID	DWR_RD0785_01_s_2016_21				
Comment Code					
C2 : Repair depressions or ruts in the crown or slope.					
Inspector Comment

View of the ruts on the crown of the levee. The direction of the river is upstream which is to the left of the picture. Spring 2016.

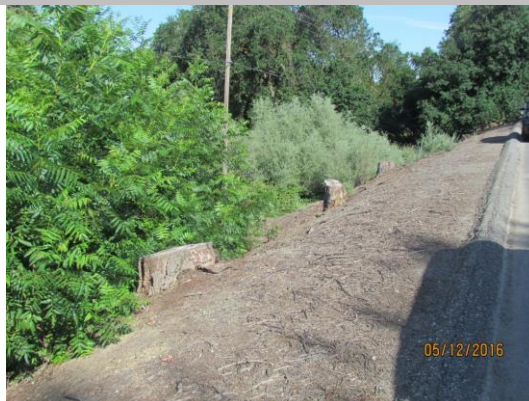
Photo 1 of 1 : SP_2016_RD0785_185_181_20160516_00036.jpg

LM Start	0.76	Rating **	N	Issue No.	181
LM End	0.76	Issue Type +	Ma	Location *	LS
Category	Earthen Levee			GPS Latitude/Longitude	
				Start	End
Item	Trim / Thin Trees			38.653003 °	38.653003 °
				-121.605061 °	-121.605061 °
DWR ID	DWR_RD0785_01_s _ 2014_181				
Comment Code					
T5 : Tree stumps.					
Inspector Comment

View of the tree stumps on the landward side of the levee looking upstream. Spring 2016.

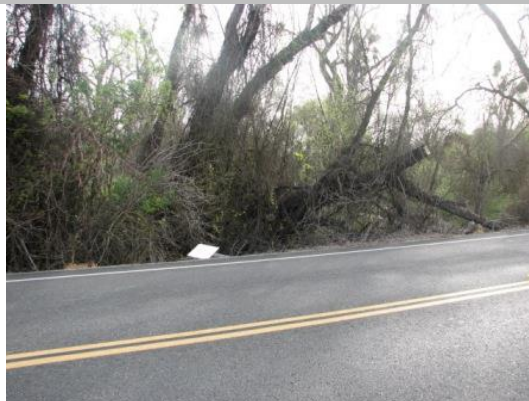
Photo 1 of 1 : SP_2016_RD0785_185_47_20160304_00009.jpg

LM Start	0.92	Rating **	M	Issue No.	47
LM End	0.92	Issue Type +	Ma	Location *	WS
Category	Earthen Levee			GPS Latitude/Longitude	
				Start	End
Item	Trim / Thin Trees			38.650992 °	38.650992 °
				-121.603392 °	-121.603392 °
DWR ID	DWR_RD0785_01_s_2012_47				
Comment Code					
T3 : Trim and thin trees to allow visibility of the ground and room to flood fight.					
Inspector Comment

The fallen tree and brush on the waterside of the roadway needs to be removed. Photo taken spring 2012.

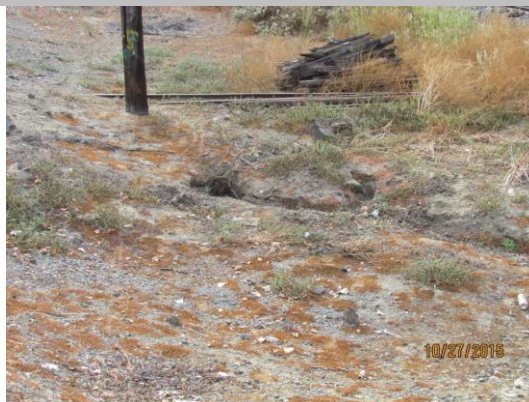
Photo 1 of 3 : SP_2016_RD0785_185_48_20160304_00011.jpg

LM Start	1.07	Rating **	M	Issue No.	48
LM End	1.07	Issue Type +	Ma	Location *	LS
Category	Earthen Levee			GPS Latitude/Longitude	
				Start	End
Item	Erosion / Bank Caving			38.649392 °	38.649392 °
				-121.601636 °	-121.601636 °
DWR ID	DWR_RD0785_01_s_2012_48				
Comment Code					
E2 : Schedule repair of erosion site prior to the next inspection.					
Inspector Comment

View of the erosion at the toe of the levee on the landward side of the levee looking downstream. Fall 2015.

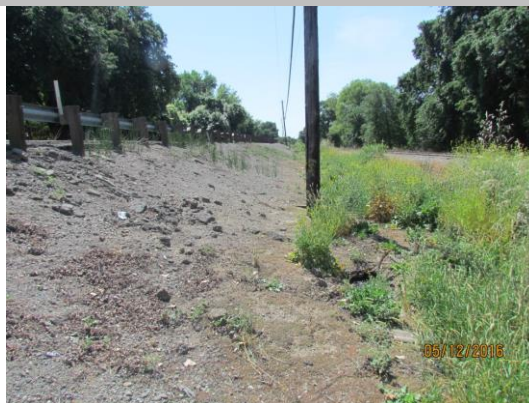
Photo 3 of 3 : SP_2016_RD0785_185_48_20160516_00041.jpg

Perspective view of the erosion on the landward side of the levee looking downstream. Spring 2016.

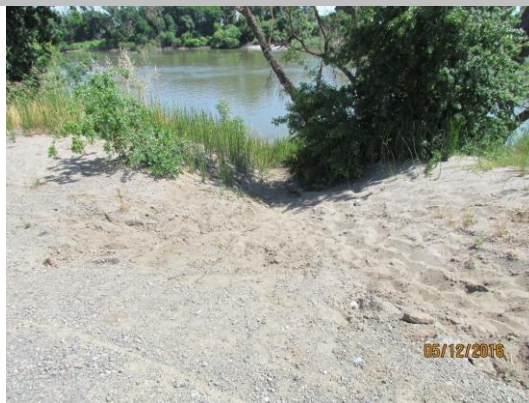
Photo 1 of 2 : SP_2016_RD0785_185_25_20160516_00038.jpg

LM Start	1.34	Rating **	M	Issue No.	25
LM End	1.34	Issue Type +	Ma	Location *	WS
Category	Earthen Levee			GPS Latitude/Longitude	
				Start	End
Item	Slope Stability			38.646240 °	38.646240 °
				-121.598505 °	-121.598505 °
DWR ID	DWR_RD0785_01_s_2016_25				
Comment Code					
S2 : Repair the levee slope damaged by foot traffic and prevent access where possible.					
Inspector Comment

View of the slope stability caused by foot traffic on the waterward side of the levee. Spring 2016.

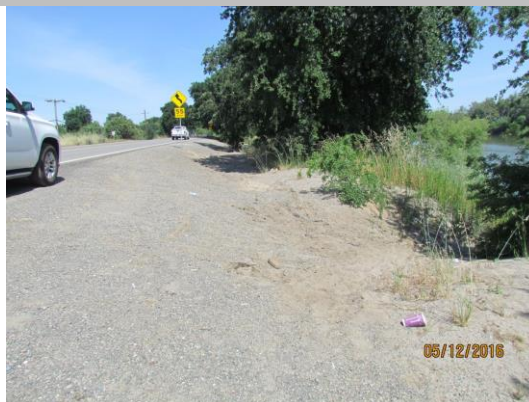
Photo 2 of 2 : SP_2016_RD0785_185_25_20160516_00039.jpg

Perspective view of the slope stability looking upstream. Spring 2016.

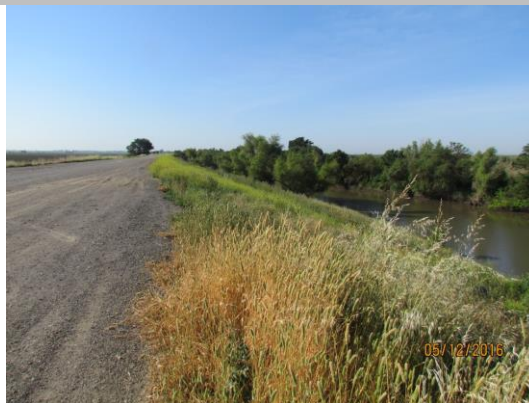
Photo 1 of 1 : SP_2016_RD0785_186_7_20160516_00021.jpg

View of the vegetation on the waterward side of the levee looking downstream. Spring 2016.

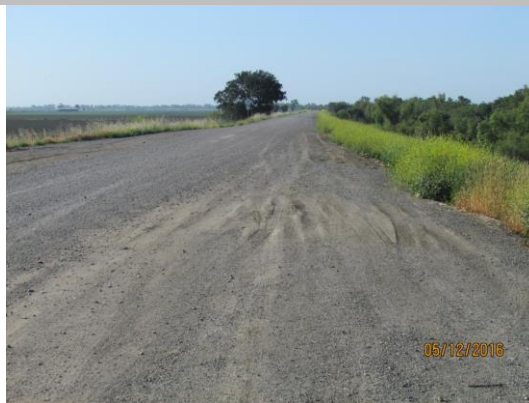
Photo 1 of 1 : SP_2016_RD0785_186_8_20160516_00022.jpg

LM Start	0.01	Rating **	M	Issue No.	8	
LM End	0.01	Issue Type +	Ma	Location *	CR	
Category	Earthen Levee			GPS Latitude/Longitude		
				Start		End
Item	Crown Surface / Depressions / Rutting			38.641105 °		38.641105 °
				-121.620402 °		-121.620402 °
DWR ID	DWR_RD0785_02_s_2016_8					
Comment Code						
C2 : Repair depressions or ruts in the crown or slope.						
Inspector Comment

View of the ruts on the crown of the levee looking downstream. Spring 2016.

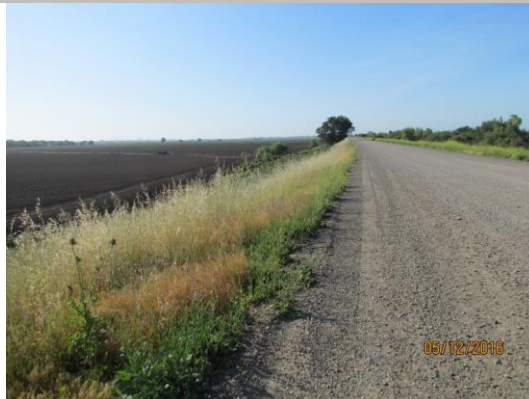
Photo 1 of 1 : SP_2016_RD0785_186_4_20160516_00023.jpg

View of the vegetation on the landward side of the levee looking downstream. Spring 2016.

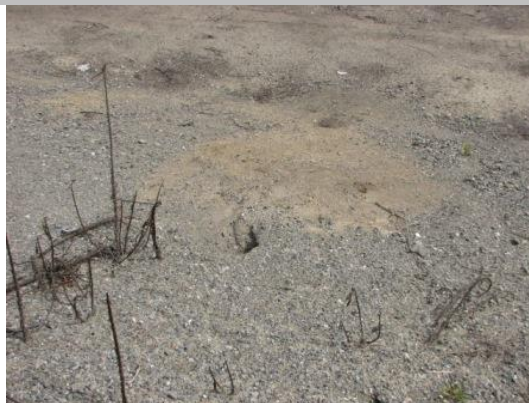
Photo 1 of 1 : SP_2016_RD0785_186_25_20160304_00004.jpg

LM Start	0.12	Rating **	M	Issue No.	25
LM End	0.12	Issue Type +	Ma	Location *	LS
Category	Earthen Levee			GPS Latitude/Longitude	
				Start	End
Item	Animal Control			38.639670 °	38.639670 °
				-121.619460 °	-121.619460 °
DWR ID	DWR_RD0785_02_s_2012_25				
Comment Code					
A3 : No rodents visible, but rodent burrows visible; need to backfill and compact or grout burrows.					
Inspector Comment					
Unable to see slope.

Rodent holes on the landside levee slope, photo taken spring 2012.

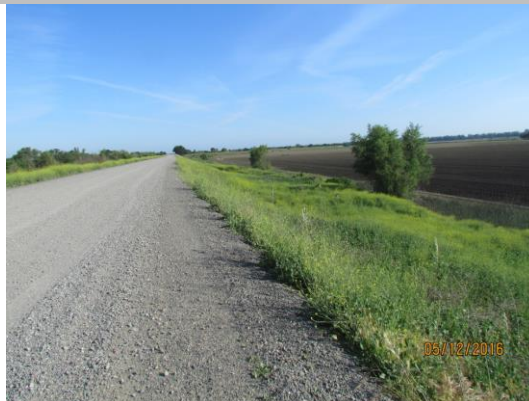
Photo 1 of 1 : SP_2016_RD0785_186_280_20160516_00024.jpg

LM Start	0.38	Rating **	M	Issue No.	280
LM End	0.38	Issue Type +	Ma	Location *	LS
Category	Earthen Levee			GPS Latitude/Longitude	
				Start	End
Item	Slope Stability			38.636265 °	38.636265 °
				-121.617422 °	-121.617422 °
DWR ID	DWR_RD0785_02_s_2015_280				
Comment Code					
S1 : Repair slope instability.					
Inspector Comment					
Seems to be a bulge at the toe of the levee.

View of the slope stability on the landward side of the levee looking upstream. Spring 2016.

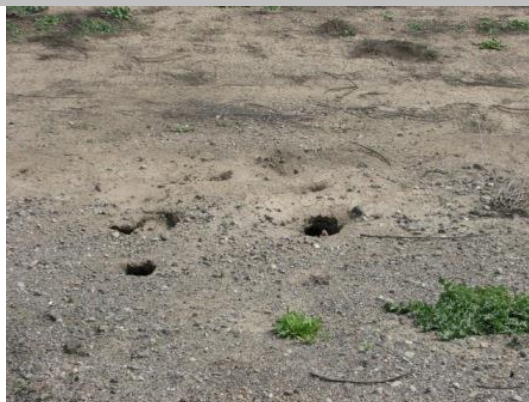
Photo 1 of 1 : SP_2016_RD0785_186_27_20160304_00005.jpg

LM Start	0.40	Rating **	A/W	Issue No.	27
LM End	0.40	Issue Type +	Ma	Location *	LS
Category	Earthen Levee			GPS Latitude/Longitude	
				Start	End
Item	Animal Control			38.636065 °	38.636065 °
				-121.617295 °	-121.617295 °
DWR ID	DWR_RD0785_02_s_2012_27				
Comment Code					
A3 : No rodents visible, but rodent burrows visible; need to backfill and compact or grout burrows.					
Inspector Comment					
Unable to see slope. Vegetation too tall to see.

Rodent holes on the landside levee slope, photo taken spring 2012.

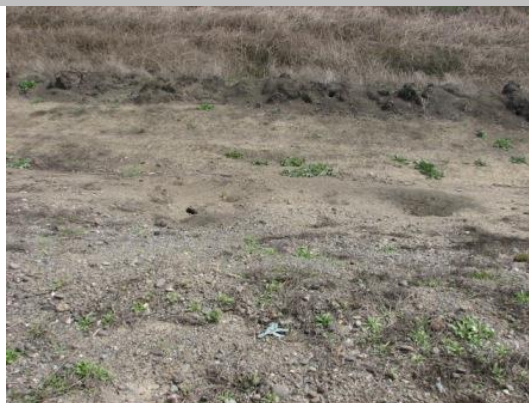
Photo 2 of 2 : SP_2016_RD0785_186_28_20160304_00007.jpg

Rodent holes on the landside levee slope, photo taken spring 2012.

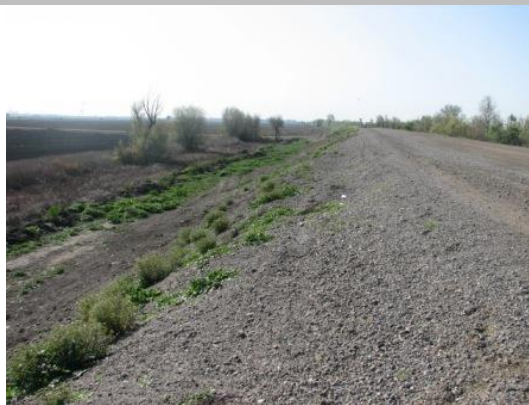
Photo 1 of 2 : SP_2016_RD0785_186_29_20160304_00008.jpg

LM Start	0.54	Rating **	M	Issue No.	29
LM End	0.54	Issue Type +	Ma	Location *	LS
Category	Earthen Levee			GPS Latitude/Longitude	
				Start	End
Item	Slope Stability			38.634130 °	38.634130 °
				-121.616130 °	-121.616130 °
DWR ID	DWR_RD0785_02_s _ 2012_29				
Comment Code					
S1 : Repair slope instability.					
Inspector Comment

Slope instability at shoulder of landside levee buldge at toe.

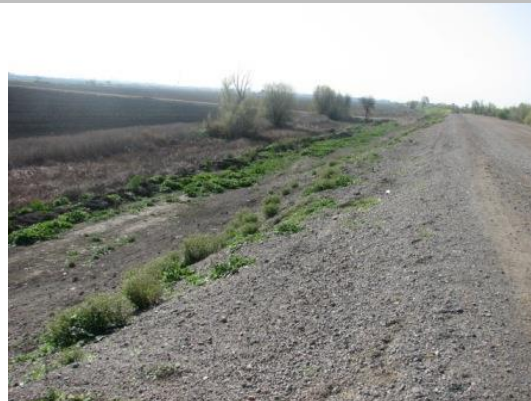
Photo 2 of 2 : SP_2016_RD0785_186_29_20160304_00009.jpg

LM Start	0.54	Rating **	M	Issue No.	29 (cont)	
LM End	0.54	Issue Type +	Ma	Location *	LS	
Category	Earthen Levee			GPS Latitude/Longitude		
				Start		End
Item	Slope Stability			38.634130 °		38.634130 °
				-121.616130 °		-121.616130 °
DWR ID	DWR_RD0785_02_s_2012_29					
Comment Code						
S1 : Repair slope instability.						
Inspector Comment

Bulge at the landside toe of the levee, photos taken spring 2012.

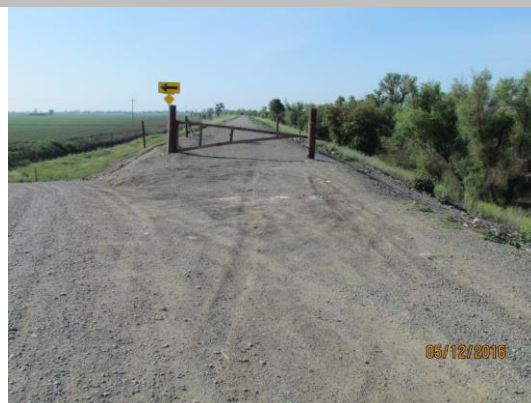
Photo 1 of 1 : SP_2016_RD0785_186_2_20160516_00025.jpg

LM Start	0.63	Rating **	M	Issue No.	2
LM End	0.63	Issue Type +	Ma	Location *	CR
Category	Earthen Levee			GPS Latitude/Longitude	
				Start	End
Item	Crown Surface / Depressions / Rutting			38.632971 °	38.632971 °
				-121.615475 °	-121.615475 °
DWR ID	DWR_RD0785_02_s_2016_2				
Comment Code					
C1 : Add appropriate material and re-grade the levee to bring the crown above the design elevation.					
Inspector Comment

View of the ruts on the crown of the levee looking downstream. Spring 2016.

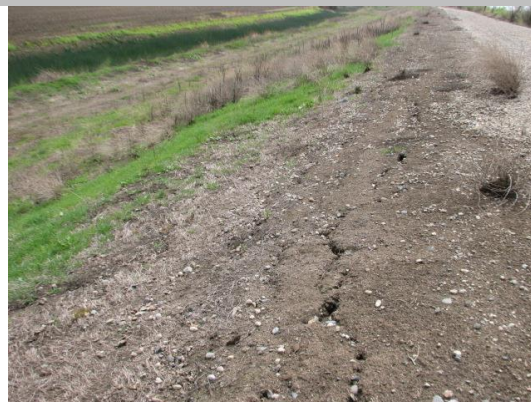
Photo 1 of 1 : SP_2016_RD0785_186_143_20160304_00017.jpg

LM Start	0.88	Rating **	M	Issue No.	143
LM End	0.88	Issue Type +	Ma	Location *	LS
Category	Earthen Levee			GPS Latitude/Longitude	
				Start	End
Item	Slope Stability			38.629693 °	38.629693 °
				-121.613436 °	-121.613436 °
DWR ID	DWR_RD0785_02_s_2014_143				
Comment Code					
S1 : Repair slope instability.					
Inspector Comment

Cracking along the shoulder causing slope instability. Spring 2014

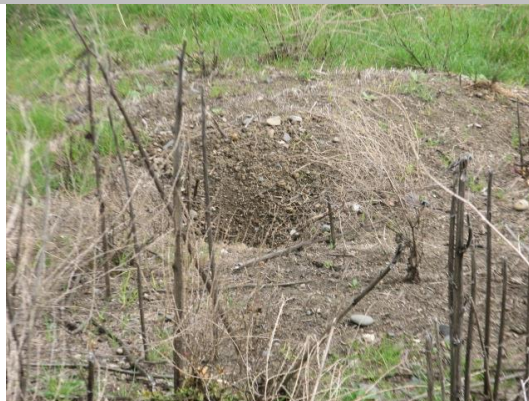
Photo 1 of 1 : SP_2016_RD0785_186_42_20160304_00014.jpg

Large rodent hole close to the toe of the levee. Spring 2014

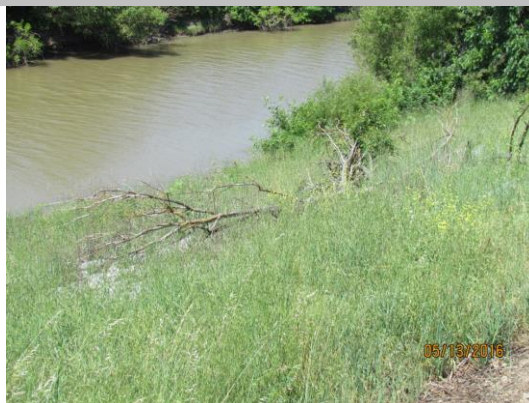
Photo 1 of 2 : SP_2016_RD0785_186_10_20160517_00031.jpg

LM Start	1.12	Rating **	M	Issue No.	10
LM End	1.12	Issue Type +	Ma	Location *	WS
Category	Earthen Levee			GPS Latitude/Longitude	
				Start	End
Item	Encroachments			38.626626 °	38.626626 °
				-121.611295 °	-121.611295 °
DWR ID	DWR_RD0785_02_s_2016_10				
Comment Code					
TR : Tree or limb					
Inspector Comment

Discarded tree is on the waterward slope of the levee. Spring 2016.

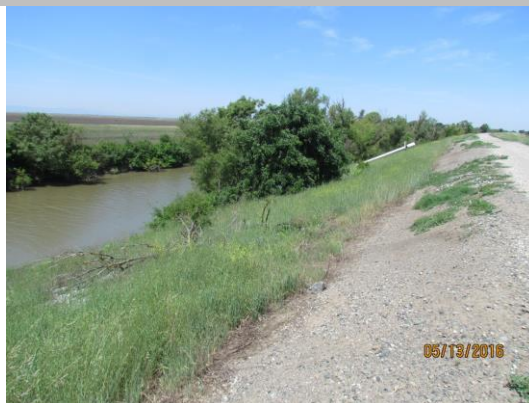
Photo 2 of 2 : SP_2016_RD0785_186_10_20160517_00030.jpg

Perspective view of the discarded tree looking upstream. Spring 2016.

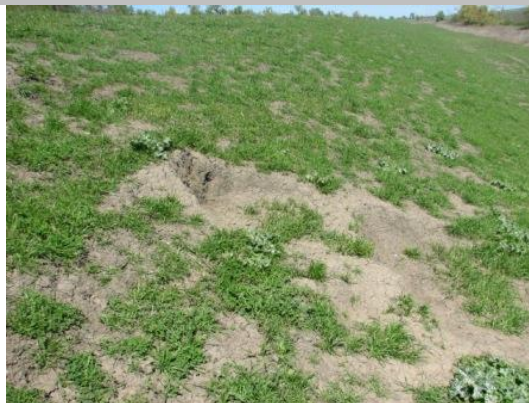
Photo 1 of 4 : SP_2016_RD0785_186_30_20160304_00010.jpg

LM Start	2.21	Rating **	M	Issue No.	30
LM End	2.21	Issue Type +	Ma	Location *	LS
Category	Earthen Levee			GPS Latitude/Longitude	
				Start	End
Item	Slope Stability			38.613104 °	38.613104 °
				-121.600915 °	-121.600915 °
DWR ID	DWR_RD0785_02_s_2012_30				
Comment Code					
S1 : Repair slope instability.					
Inspector Comment					
Spring 2016: cannot tell if issue has been fixed due to vegetations.

There is slope instability with three step like spots. The cuts are 1' to 1.5' deep. Photo taken spring 2012.

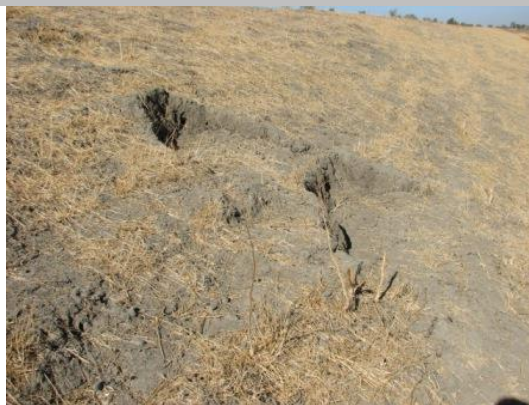
Photo 2 of 4 : SP_2016_RD0785_186_30_20160304_00011.jpg

Slope instability. Photo fall 2012.

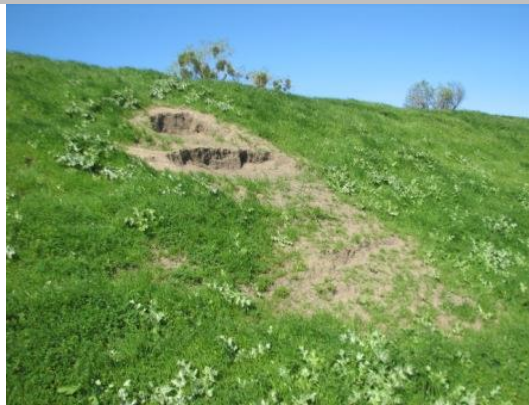
Photo 3 of 4 : SP_2016_RD0785_186_30_20160304_00012.jpg

Slope instability is still there. Spring 2013

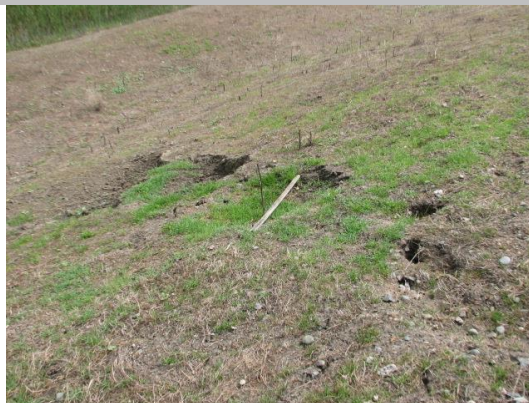
Photo 4 of 4 : SP_2016_RD0785_186_30_20160304_00013.jpg

LM Start	2.21	Rating **	M	Issue No.	30 (cont)	
LM End	2.21	Issue Type +	Ma	Location *	LS	
Category	Earthen Levee			GPS Latitude/Longitude		
				Start		End
Item	Slope Stability			38.613104 °		38.613104 °
				-121.600915 °		-121.600915 °
DWR ID	DWR_RD0785_02_s_2012_30					
Comment Code						
S1 : Repair slope instability.						
Inspector Comment						
Spring 2016: cannot tell if issue has been fixed due to vegetations.

Current view of the slope instability. Spring 2014

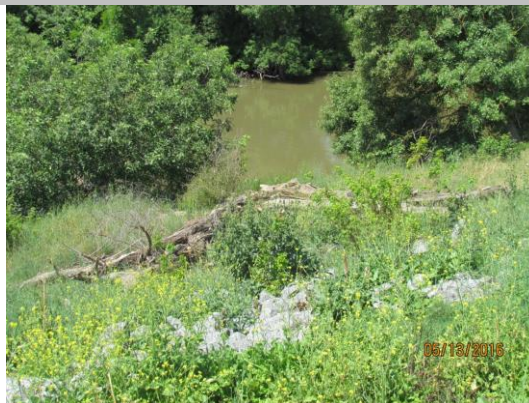
Photo 1 of 2 : SP_2016_RD0785_186_56_20160517_00028.jpg

Discarded tree is on the slope of the waterward side of the levee. Spring 2016.

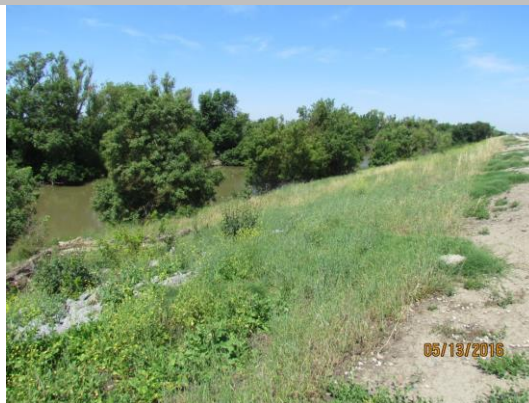
Photo 2 of 2 : SP_2016_RD0785_186_56_20160517_00029.jpg

Perspective view of the tree looking upstream. Spring 2016.

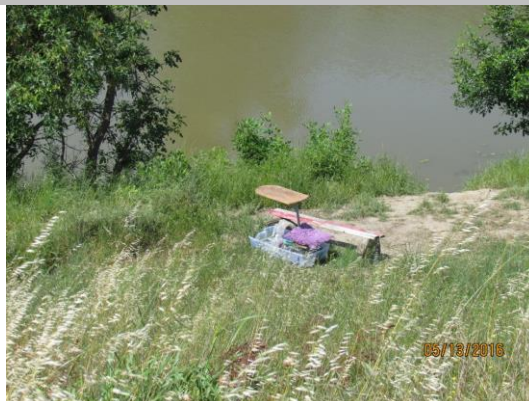
Photo 1 of 2 : SP_2016_RD0785_186_9_20160517_00026.jpg

LM Start	3.27	Rating **	M	Issue No.	9 (cont)
LM End	3.27	Issue Type +	Ma	Location *	WS

Bench is on the berm of the waterward side of the levee. Spring 2016.

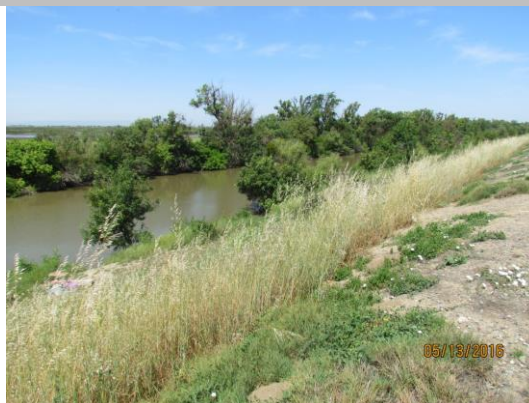
Photo 2 of 2 : SP_2016_RD0785_186_9_20160517_00027.jpg

Perspective view of the bench looking upstream. Spring 2016.
